# BULLETIN

## *PRODUCT SERVICES - Schaumburg*

Subject: MSR2000 and MSF5000 Ferro Resonant power supplies,  
TPN1185A, TPN1218A, TPN1184A, TPN1192A, TPN1226A, TPN1227A

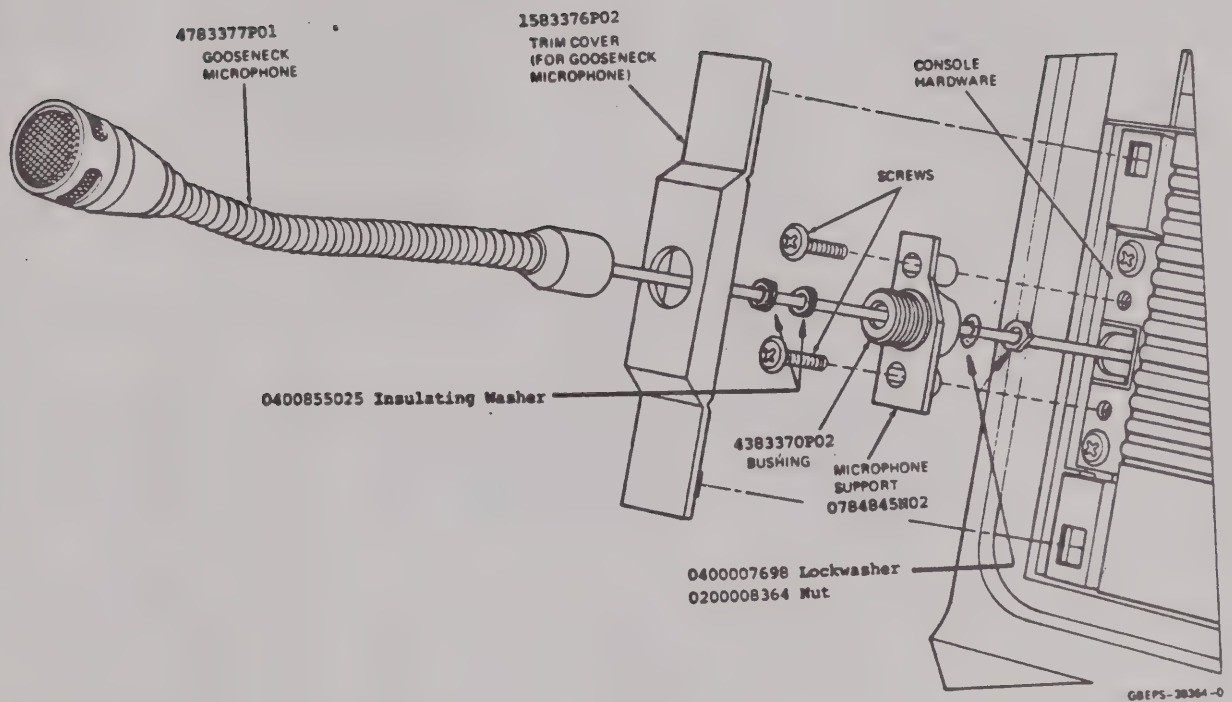
*Figure 8. Gooseneck Microphone Assembly*

Recent field reports advise that the microphone's threaded mounting bushing may slip when the gooseneck is being installed and thus preclude proper tightening. Also, since the bushing and gooseneck can slip together, microphone removal for servicing it or items related to the radio control panel may become somewhat difficult. If the slippage is evident refer to the diagram at the end of this bulletin and utilize the following recommendations.

5. Replace the flat washer (0400007641) with an internal star lock washer (Part # 0400007698). Reinstall nut and tighten securely.
6. Re-solder the phono connector making sure that the connections are not shorted.
7. Re-install completed assembly on enclosure rail and screw gooseneck mic hand tight.

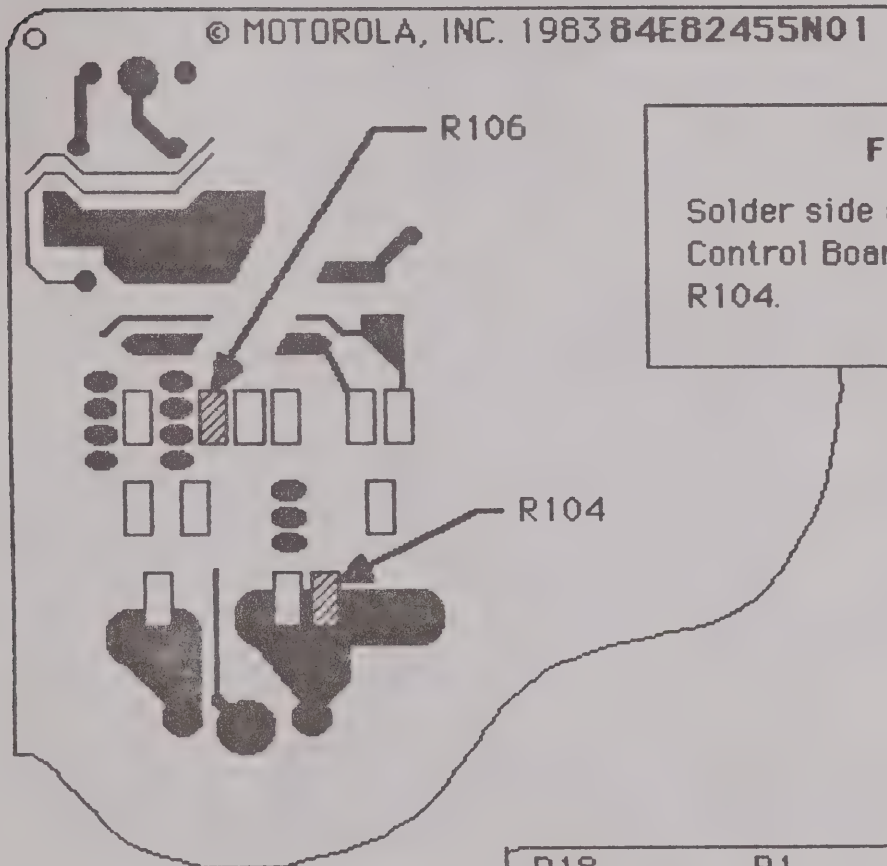
**Figure 1.**

Solder side of BLN6612A Master Control Board. Remove R106 and R104.

The new replacement for R104 and R106 should be a 5%, 1/4 watt resistor. Motorola part numbers for the resistors listed are given below.

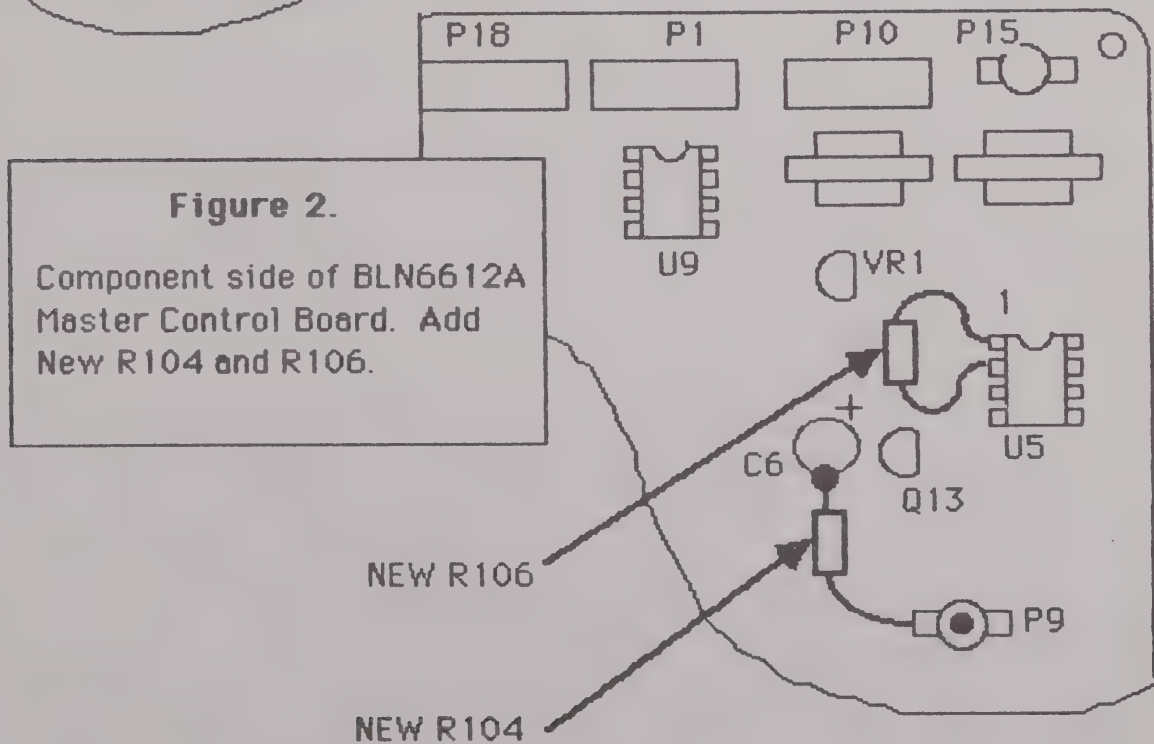
**Figure 2.**

Component side of BLN6612A Master Control Board. Add New R104 and R106.

The BLN6612A should be replaced in the tray and all cables reconnected. Now the microphone should be tested for correct operation.

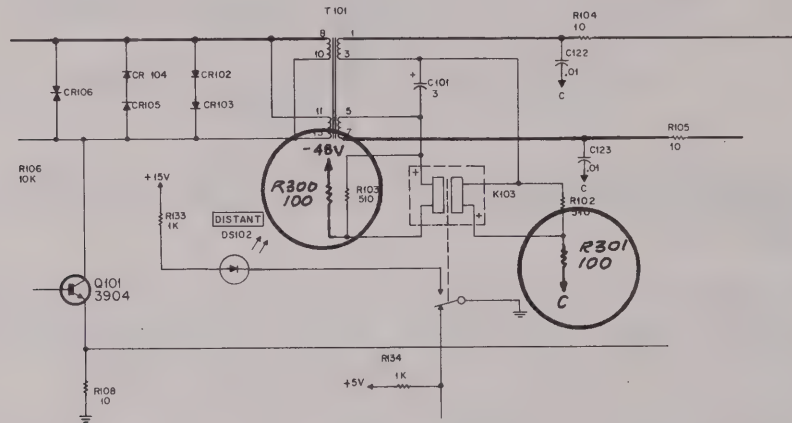
Figure 1. Partial Schematic of I/O Trunk Board TRN6469A Showing Location of Resistors R300 and R301

Only boards identified with the part number 84E84307K01 need be checked. Later boards, which bear a different part number, are not affected.

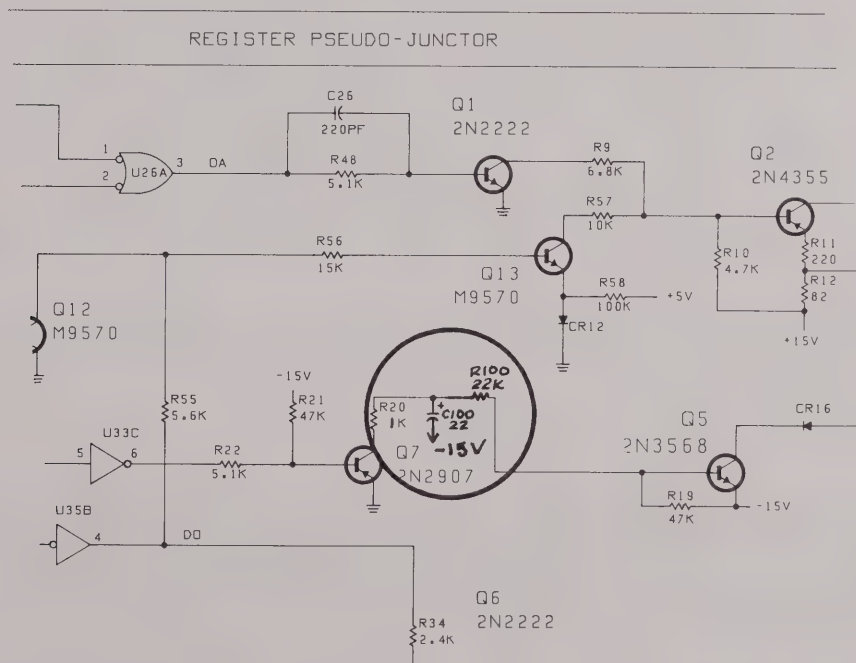
Figure 7. Partial Schematic of TRN6470B-1 and TRN6470C-1 Register Control Boards

On terminals that shipped between March 30, 1979, and April 24, 1979, the aforementioned delay was achieved by the addition of a resistor-capacitor network (R20, R100, C100) to the Register Control Board as shown in Figure 7. These boards are marked "TRN6470B-1" and "TRN6470C-1". In certain infrequent situations this network can cause complications in processing calls, therefore it should be disabled before making the modification described below. To disable the network, disconnect the negative side of capacitor C100 from the point where it connects to the board.

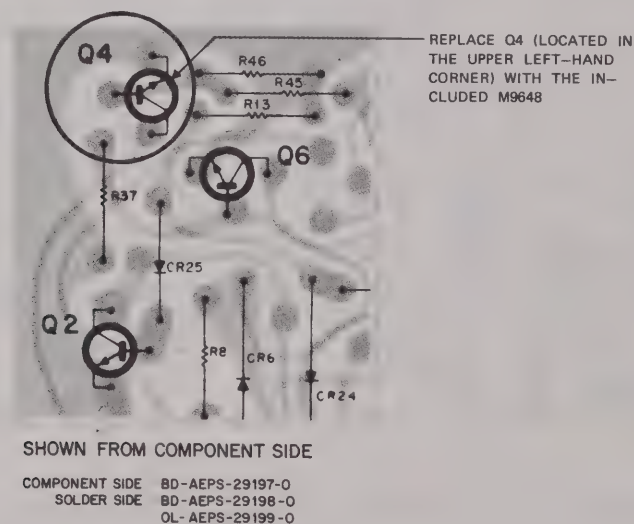
Figure IV-1. Q4 Location on TLN5252 and TLN5254 Supervisory Boards

1. The "Transmit Disable Switch", Q4 (Q6 in some early version manuals), on "PULSAR" radio supervisory boards must mute a much lower impedance microphone circuit for "PULSAR 100" and PULSAR II" radios than for earlier model control heads. The proper device must be used for the mute switch or insufficient muting may result. All "PULSAR 100" control head models could be affected.
2. To ensure sufficient "PULSAR 100", or "PULSAR II" microphone audio muting, Q4 on the radio supervisory board must be a type M9648. Early versions of the supervisory boards used a type M9642 transistor, which should be replaced with a type M9648. Refer to Figure IV-1 for location details.

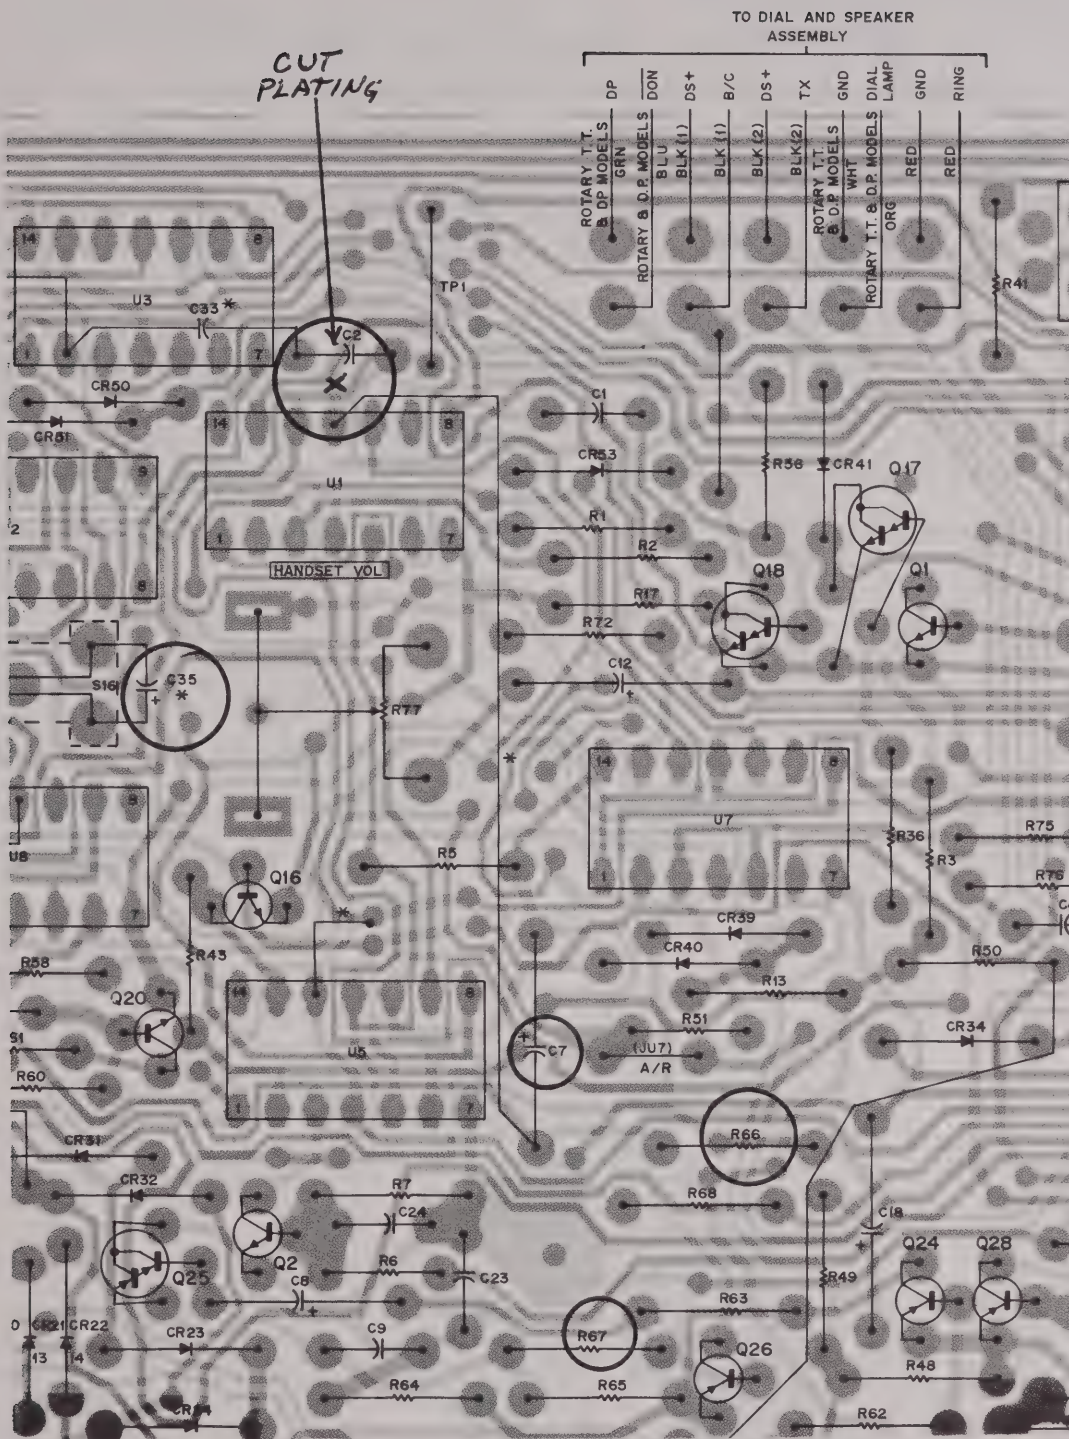
Figure III-1. Cradle Circuit Board Partial Diagrams

1. Excessive mechanical hookswitch bounce can sometimes occur when the "PULSAR 100" Control head is subjected to severe shock or vibration. If the handset is removed from the cradle, as in making a phone call, the leaf switch (hookswitch) contacts could momentarily open, causing an RCC control head to unlatch the transmitter (in the manual mode) or cause the control head to re-key itself during reverive operation. Under conditions of extreme vibration an RCC or Telco Control Head may experience audio breakup due to the hookswitch muting and unmuting the audio path. From initial production, the hookswitch leaves have been adjusted to minimize these effects and are tested for proper performance. However, additional circuitry can be added to the cradle board to effectively "filter" out intermittent switch "opens" during shock or vibration.

3. The modification is as follows. Refer to Figure III-1 for the recommended part placement positions and PC board runner cut. On both RCC and Telco and Bell Control Heads, add R66 and C7; refer to Figure III-1 for location. Do not solder C7 in yet as a

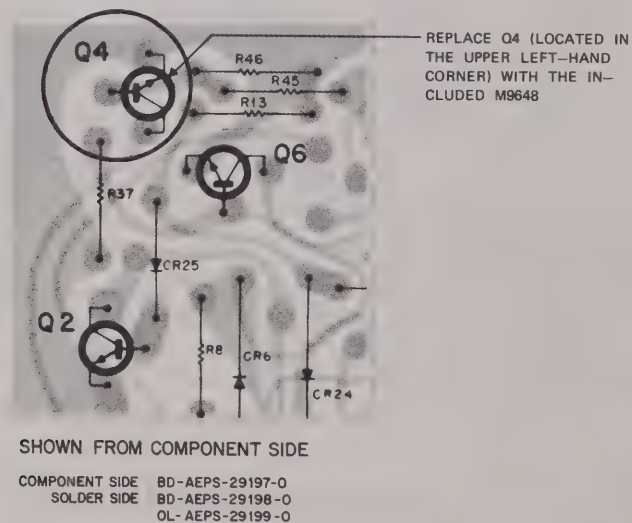
Figure IV-1. Q4 Location on TLN5252 and TLN5254 Supervisory Boards

1. The "Transmit Disable Switch", Q4 (Q6 in some early version manuals), on "PULSAR" radio supervisory boards must mute a much lower impedance microphone circuit for "PULSAR 100" and PULSAR II" radios than for earlier model control heads. The proper device must be used for the mute switch or insufficient muting may result. All "PULSAR 100" control head models could be affected.
2. To ensure sufficient "PULSAR 100", or "PULSAR II" microphone audio muting, Q4 on the radio supervisory board must be a type M9648. Early versions of the supervisory boards used a type M9642 transistor, which should be replaced with a type M9648. Refer to Figure IV-1 for location details.

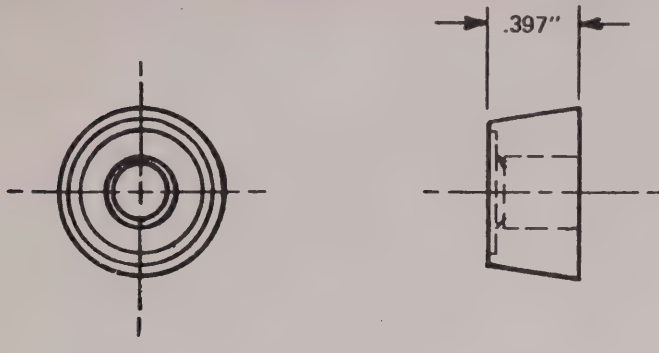
Figure VI-1. Old Mike Grommet

Field reports have indicated that some "PULSAR 100" Control Heads are susceptible to audio feedback between speaker and mike in the handset. The cause of the problem has been traced to the black grommet that surrounds the mike. This problem has been eliminated by replacing the black mike grommet with the new grommet part number 05-83044M01. This new grommet (Figure VI-2) is longer and has a smaller O.D. than the original grommet (Figure VI-1).

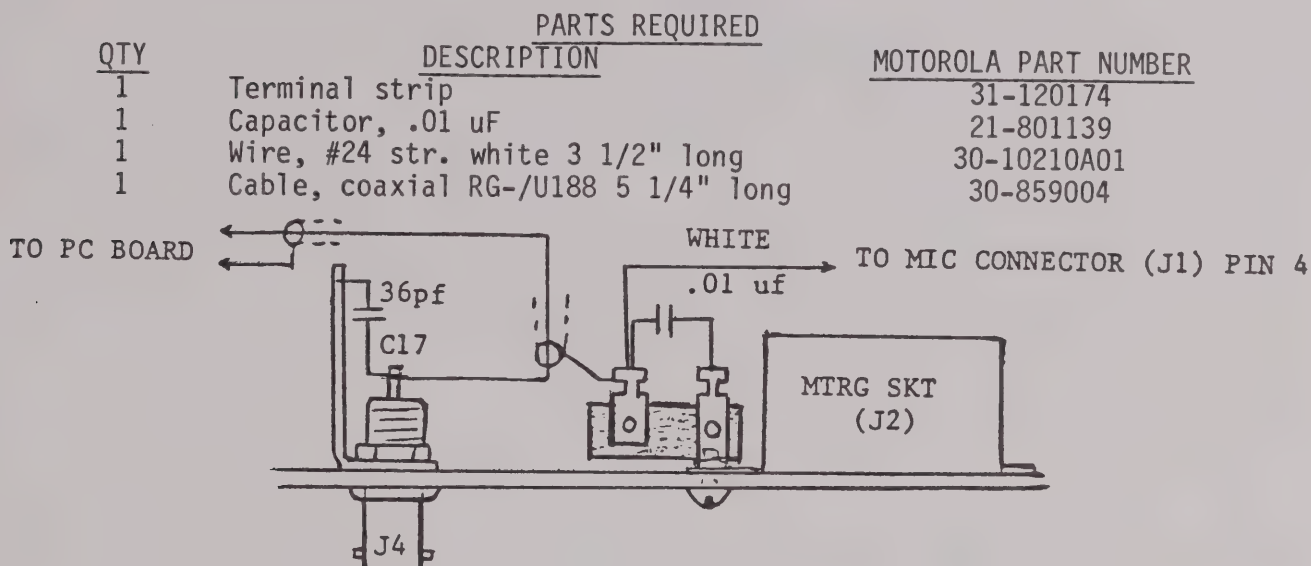
Figure 3. Meter Panel Detail

This modification isolates the Portable Test Set panel from the vehicle chassis DC reference. This allows proper "in vehicle" servicing of a positive ground "Mitrek" or "Mocom" radio.

- 4.2.1 Obtain the following parts and refer to Figure 3.
- 4.2.2 Remove the ground strap from the meter mounting screw and the "Xmtr On" switch (S5).
- 4.2.3 Remove the GRN shielded lead from the P.C. board to the RF BNC connector J4.
- 4.2.4 Solder the .01 uF capacitor to terminal strip, keeping leads as short as possible.
- 4.2.5 Mount the terminal strip with capacitor to meter panel using metering socket J2 mounting screw.
- 4.2.6 Connect a 3 1/2" piece of WHT wire (#24 stranded) from the insulated terminal of the added terminal strip to the "Microphone" socket J1, pin 4.
- 4.2.7 Connect a piece of RF coaxial cable (5 1/4" long) to the P.C. board where the GRN shielded cable was removed.
- 4.2.8 Connect the shield of the coax cable to the insulated terminal of the added strip.
- 4.2.9 Connect the center conductor of the coax cable to the center of the BNC connector J4.

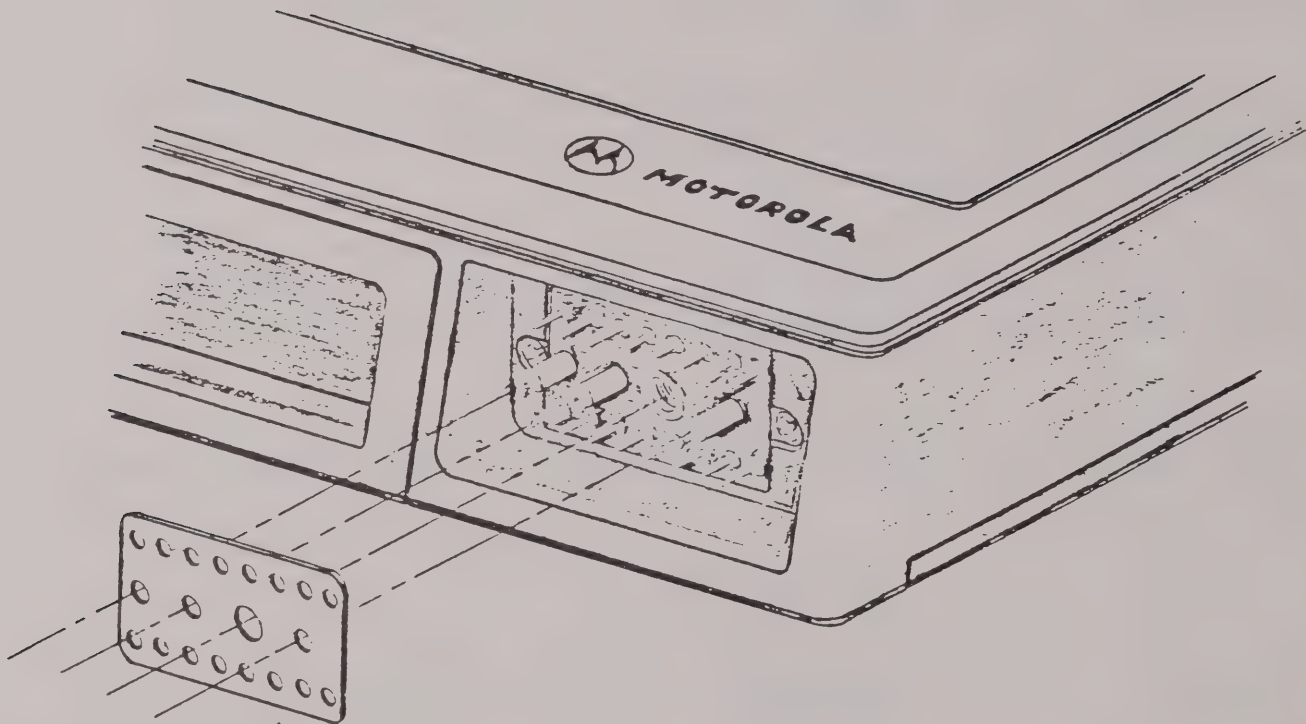
"Outside" Front Plug Gasket  
(Part #32-80020C01)

The 19 pin front plug gasket was added to prevent corrosion of the connector pins when standing water is present in the connector pocket. The front plug gasket slides over the pin contacts and is held in place by the control cable plug.

Engineering recommends that a front plug gasket be installed on all "Mitrek" units which shipped prior to October, 1979 and are vertical mounted with the connector up. (See following drawing on Page 2).

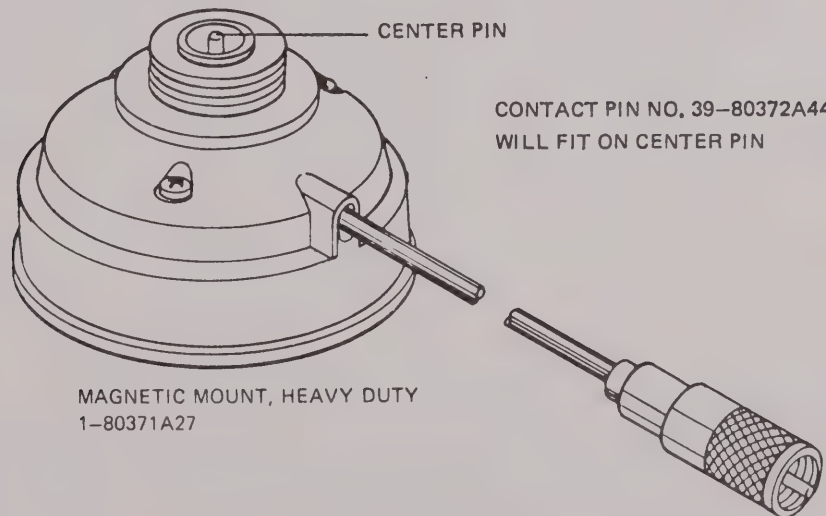
MAGNETIC MOUNT, HEAVY DUTY  
1-80371A27

When using the magnetic mount (Motorola No. 01-80371A27) to mount mobile antenna series RRA-4686A thru RRA-4690A, an additional part is required to fit on the center pin of the mount. This will correct intermittency problems caused by the center pin not making the proper contact with the mount. The part, supplied at no charge until 9/30/82 is a contact pin, Motorola Part Number 39-80372A44, and is available from C & E Parts. Antennas purchased after 6-11-82 will have the additional part included. This is a service aid bulletin. No charges will be accepted.

CONTACT PIN NO. 39-80372A44  
WILL FIT ON CENTER PIN

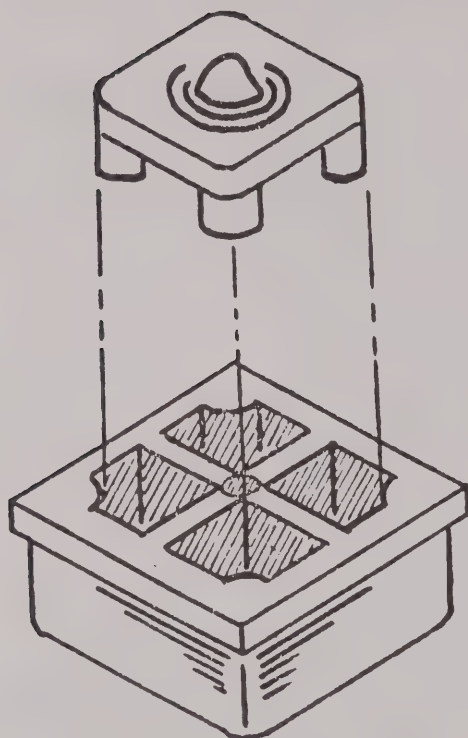
In response to field inputs, regarding broken stems under the key cap buttons on the KDT-240 keyboard and also problems associated with ordering replacements, Engineering has designed a universal plastic insert (Motorola part no. 38-84506M01) which will correct the problem of broken stems without replacing the actual button. The stocking of a small number of these inserts by the service shops will help them reduce or eliminate their inventories for the numerous alphanumeric characters used on this keyboard.

← ELASTOMER INSERT  
38-84506N01

1. Remove the keyboard from the KDT by referring to the instruction manual 68P81036E90 under the maintenance section.
2. Place the keyboard face down on a flat surface, remove remaining screws, and lift off the back cover.
3. Remove defective key cap(s).
4. Prepare key cap for plastic insert by removing excessive mold flash from the four cavities (see attached pictorial). NOTE: If flash is not removed, the insert may not seat properly and could cause continual activation of the contact.
5. Insert the plastic insert in key cap and replace key cap cover.
6. Assemble keyboard to the KDT and make sure all keys work properly.

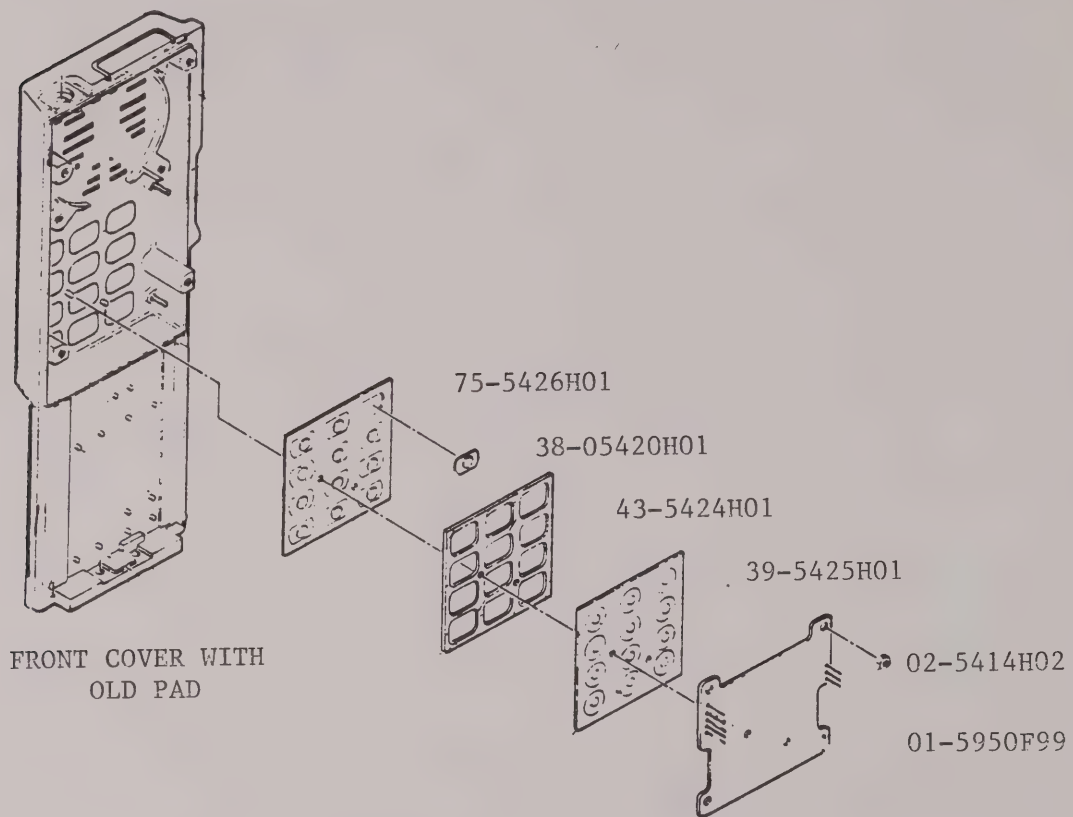
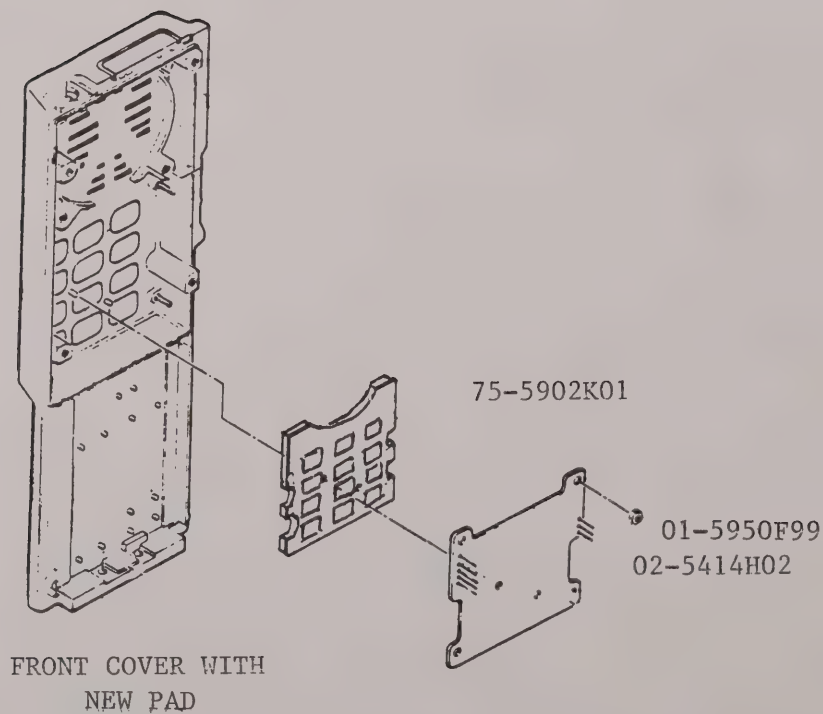
Figure 1

A new touch code pad has been designed and should be installed whenever a portable equipped with touch code comes in for maintenance. This pad has carbon filled contacts which replaces four parts on the front cover. Refer to Figure 1. The new pad, (Part #75-5902K01) is a drop-in replacement, no modification need be made to the radio except the ones called out in the following instructions.

4. Carefully lift out the circuit board.
5. Remove the (4) hex nuts holding down the contact board.
6. Refer to Figure 1. The new pad (P/N 7505902K01) will replace the contact pad (P/N 3905425H01), the spacer key (P/N 4305424H01), buttons (P/A3805430H01), and the old pad (P/N 7505426H01).

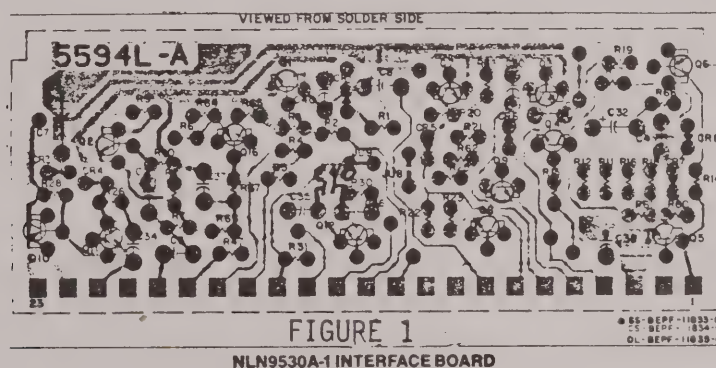
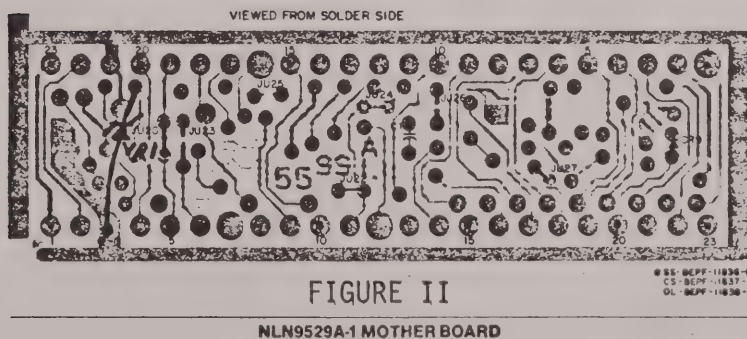
It has come to our attention that in some radios shipped before March 15, 1984 (AJF - S/N), the emergency circuit can be activated by a static charge. This problem can be eliminated by removing capacitors C35 and C36 on the interface board (NLN9530A) and adding capacitor C40. (Part Number 21-82213E08, see Figure 1). Also add 10 volt zener diode (VR1) from I18 to ground on the solder side of the mother board (NLN9529A), see Figure II. The part number for VR1 is 48-82256C11.

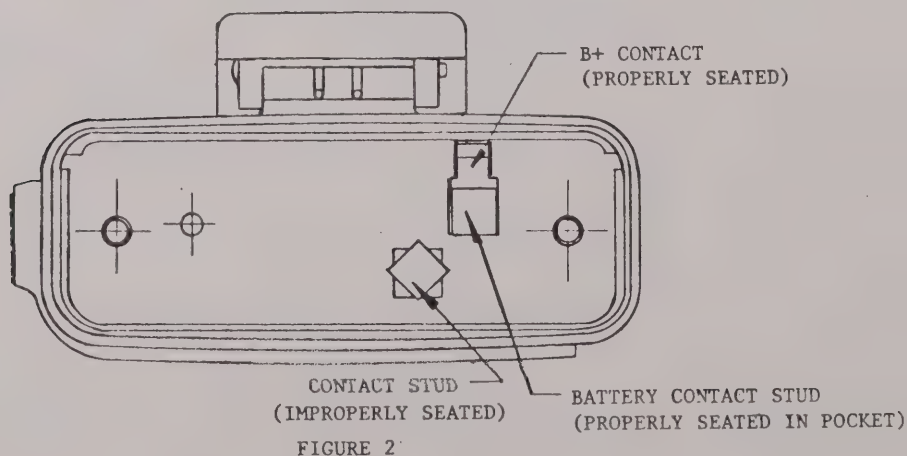
- Step 7: Remove the transceiver kit from the housing and check to make sure the battery contacts are squarely seated in their pockets. (See Figure 2).

- Step 8: If contact is not properly seated in pocket as shown in Figure 2, loosen battery contact screw and rotate stud into properly seated position and retighten screw to appropriate torque.

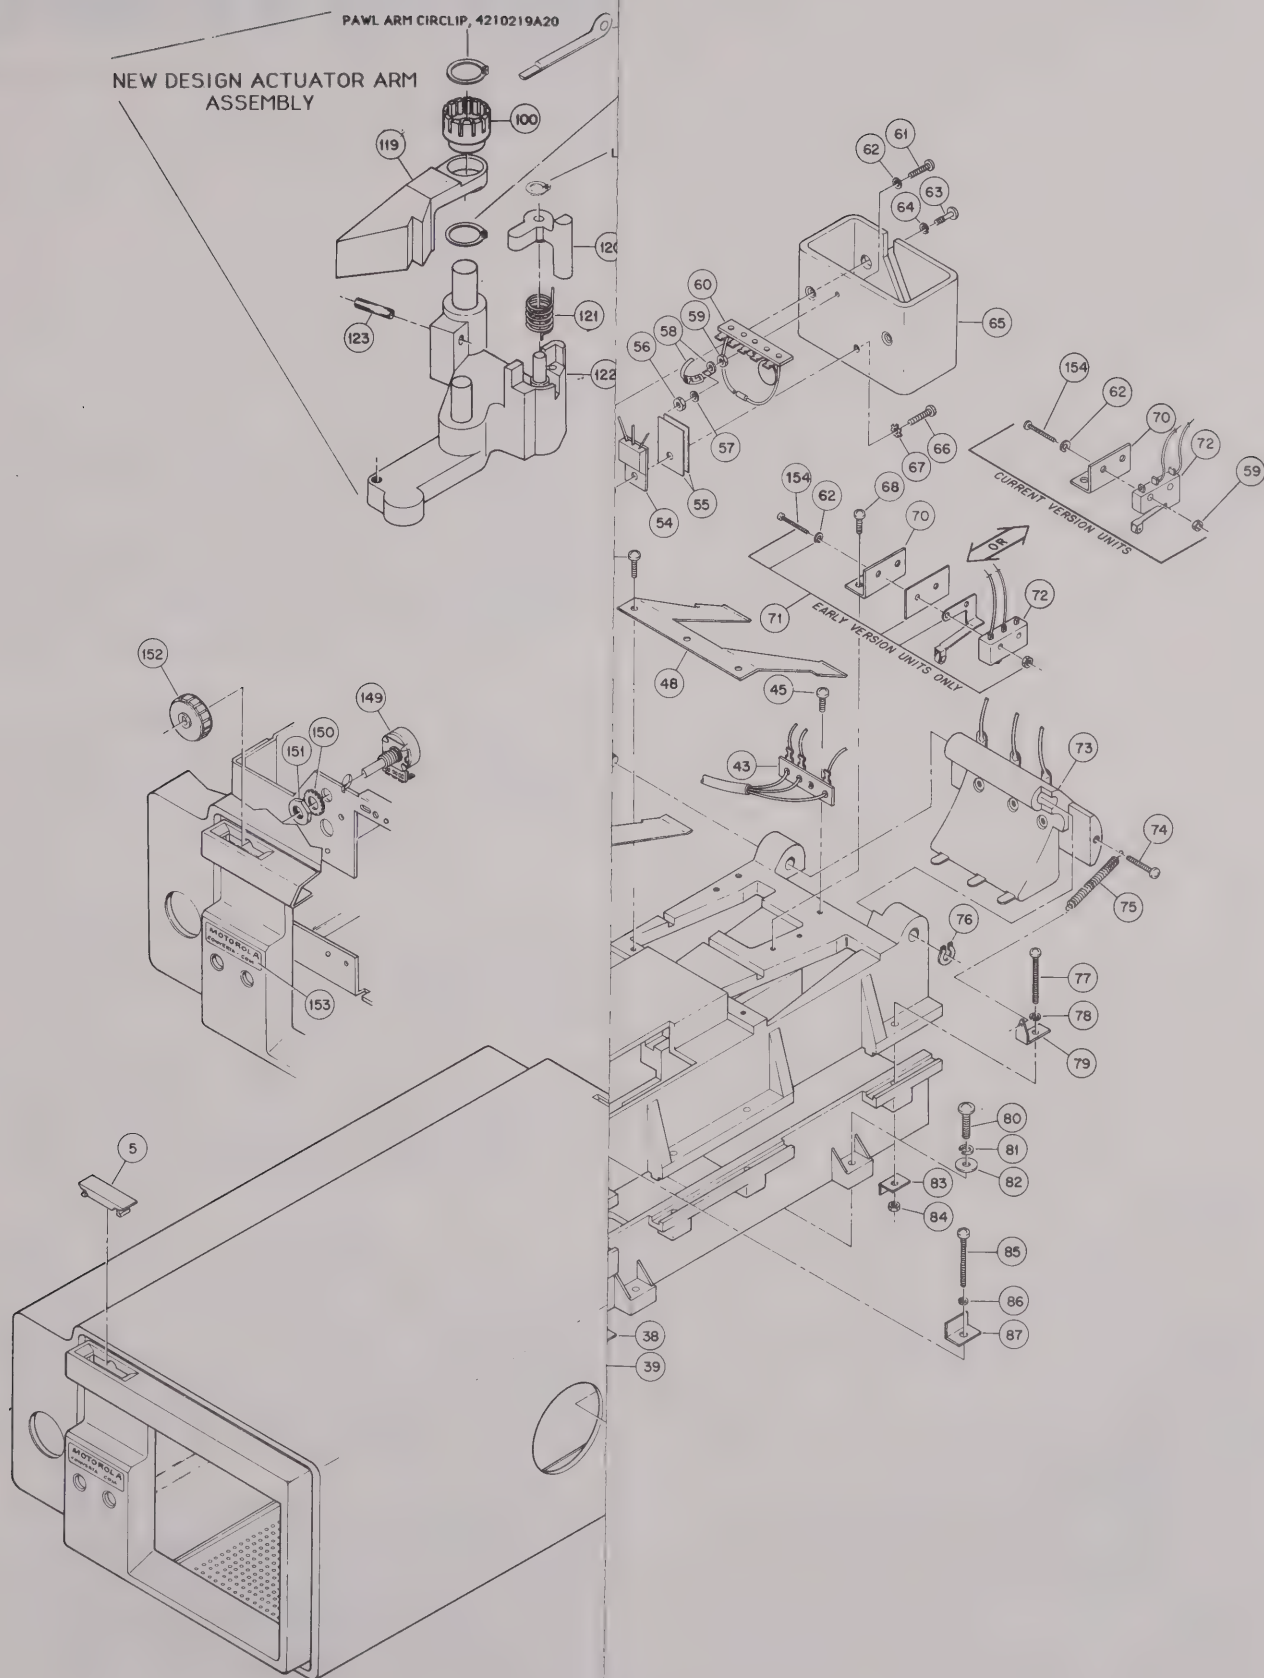
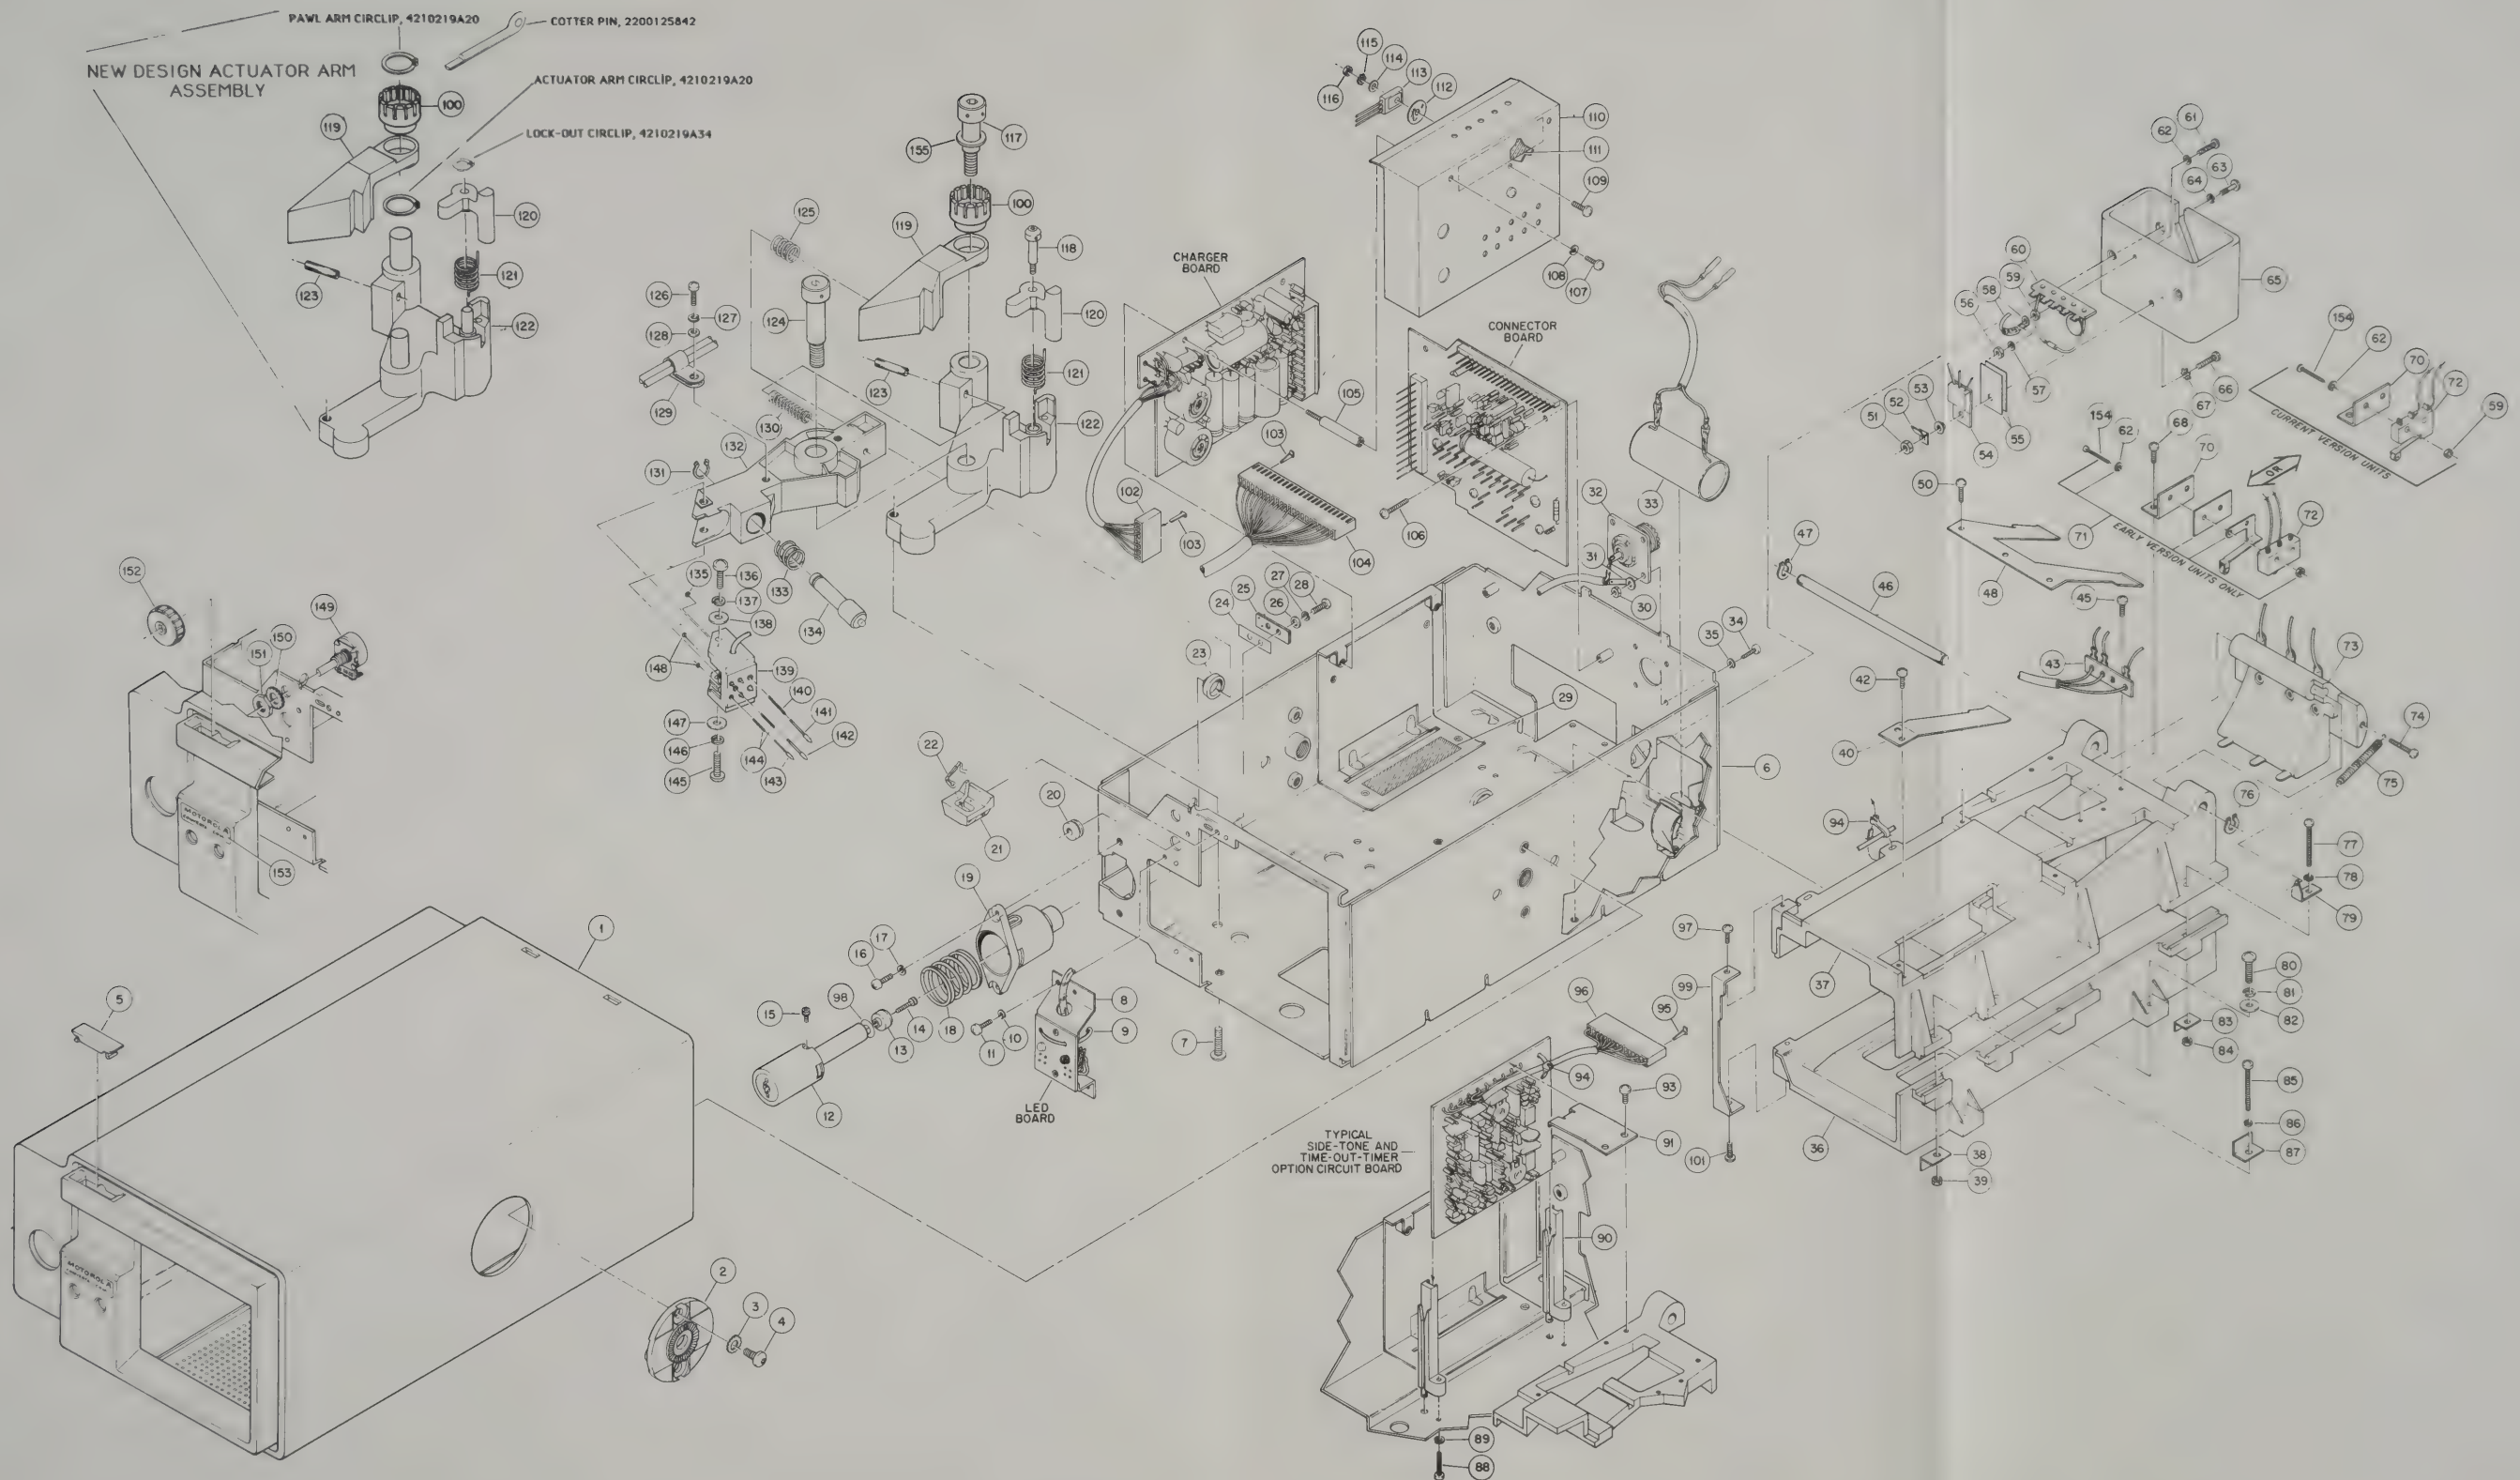
The locating pin (134) has been redesigned to provide for deeper penetration into the side of the retained MT portable. This new locating pin is directly retrofitable to all existing Converta-Coms.

(3) Loctite thread locking compound (1110019B14) has been added to the four screws (80) retaining the pocket (36) assembly to the Converta-Com chassis (6), the two screws (136) retaining the contact block (139) assembly to the actuator arm (132), and the two screws (154) which retain the S1 switch (72) to its right-angle bracket (70). A word of caution; when applying Loctite, or any other thread-locking compound containing cyanoacrylates, care must be taken to assure none of the compound comes in contact with any plastic parts. These compounds can degrade their accompanying plastic parts, if indiscriminately used.

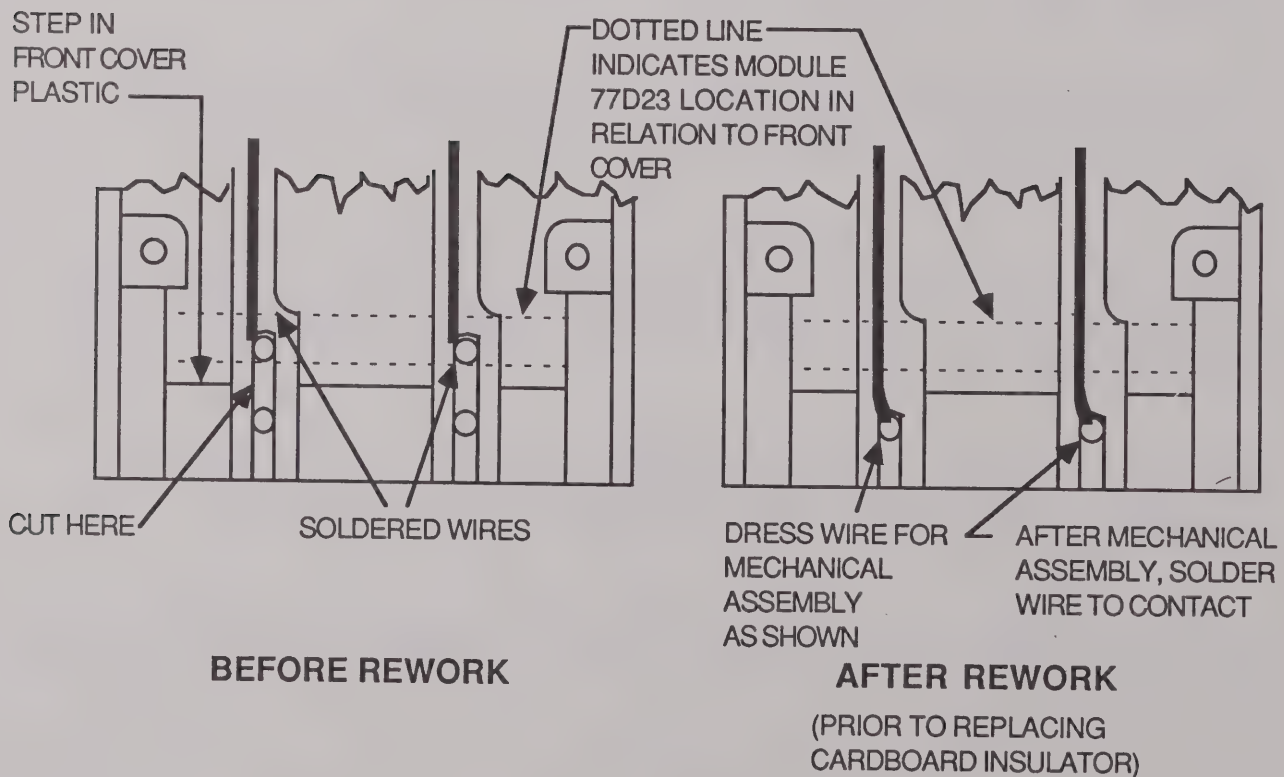
## REWORK PROCEDURE FOR MT500 FRONT COVER WHEN PL PROCESSOR 5105177D23 CAUSES INTERFERENCE.

1. REMOVE THE CARDBOARD INSULATOR COVERING CONTACT STRAPS AT THE LOWER END OF THE FRONT COVER, ABOVE THE BATTERY COMPARTMENT.
2. UNSOLDER AND REMOVE BOTH LEAD WIRES FROM THE TWO CONTACTS.
3. CUT BOTH CONTACTS SO THAT THE END HOLE OF EACH IS REMOVED TO THE VISIBLE EDGE OF A RAISED STEP IN THE FRONT COVER PLASTIC. (SEE DIAGRAM BELOW).
4. REDRESS AND SOLDER BOTH WIRES TO THE SAME CONTACT STRIPS THEY WERE REMOVED FROM AND INTO THE REMAINING HOLE IN THE CONTACT STRIPS.
5. REPLACE THE CARDBOARD INSULATOR.

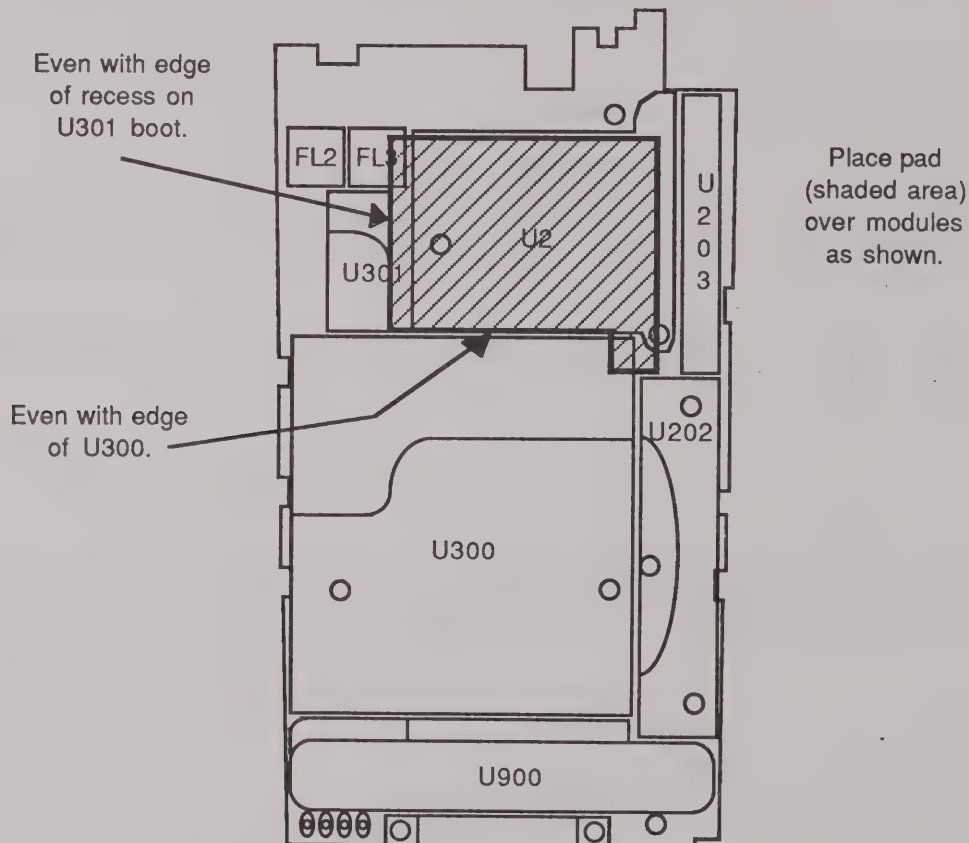
There is a shock pad located between the LCD printed circuit board assembly and the modules in all secure Saber II and III radios. The pad part number is incorrect in issue O secure service manual 68P81045C70-O ( Manual 68P81045C75-O is correct; manual C70-O was corrected by FMR1322-3). Should a shock pad for a DVP radio need replacement it should be ordered as kit #NTN5421A and adhered to the tops of the modules as shown in the diagram below. When replacing radio modules, ensure that the shock pad is reinstalled.

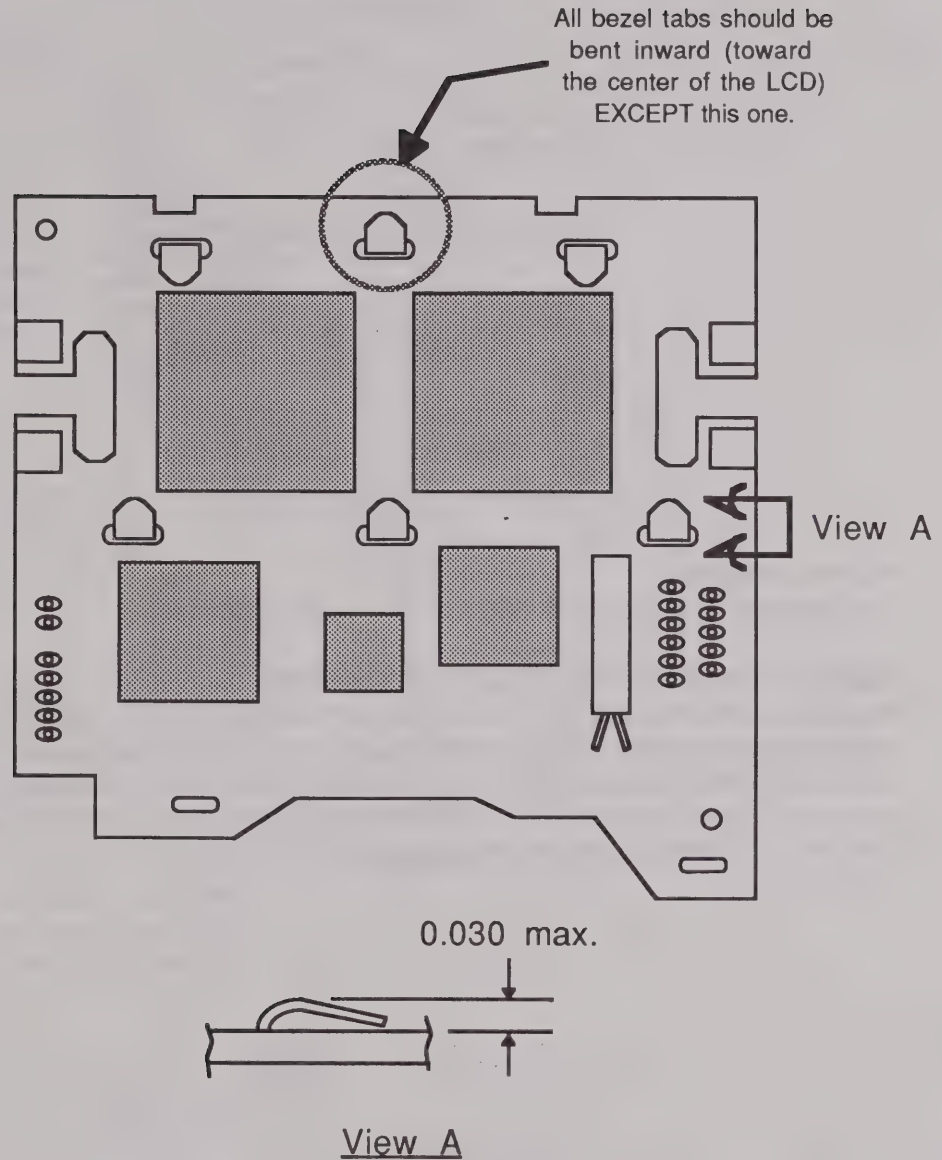
## DIAGRAM A

If the LCD bezel tabs on the Saber display board assembly are not bent in the proper directions shorting can occur between the tabs and the controls flexible circuit. When repairs must be made on this board assembly, make sure that the LCD bezel tabs are bent over in the configuration shown in the diagram **A**.
